**DEPARTMENT OF TRANSPORTATION**

Contract #: 04-0120F4Cty: SF/ALA Rte: 80 PM: 13.2/13.9File #: 1.28**WELDING INSPECTION REPORT****Resident Engineer:** Casey, William**Address:** 333 Burma Road**City:** Oakland, CA 94607**Report No:** WIR-028232**Date Inspected:** 21-Aug-2012**Project Name:** SAS Superstructure**OSM Arrival Time:** 700**Prime Contractor:** American Bridge/Fluor Enterprises, a JV**OSM Departure Time:** 1930**Contractor:** American Bridge/Fluor Enterprises, a JV**Location:** Jobsite**CWI Name:** Berry Drake**CWI Present:** Yes No**Inspected CWI report:** Yes No N/A**Rod Oven in Use:** Yes No N/A**Electrode to specification:** Yes No N/A**Weld Procedures Followed:** Yes No N/A**Qualified Welders:** Yes No N/A**Verified Joint Fit-up:** Yes No N/A**Approved Drawings:** Yes No N/A**Approved WPS:** Yes No N/A**Delayed / Cancelled:** Yes No N/A**Bridge No:** 34-0006**Component:** OBG 13 / 14 West**Summary of Items Observed:**

# WELDING INSPECTION REPORT

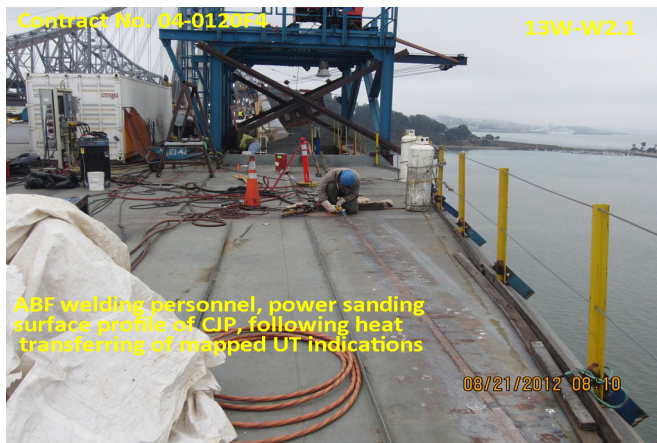
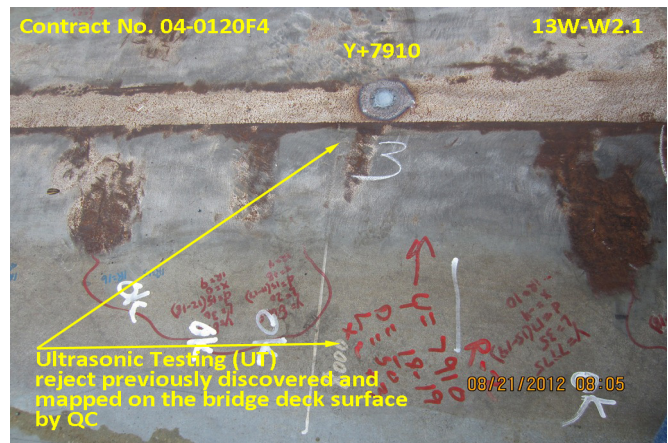
This QAI inspector observed ABF welding personnel heat transferring the location of Ultrasonic Testing (UT) rejects previously discovered and mapped on the bridge deck surface by QC, with the aid of OXY/FUEL cutting torch. The weld is a Complete Joint Penetration (CJP) butt joint for the OBG deck and is designated as 13W-W2.1.

The location of such heat transferring occurred at Y+248, Y+5180, Y+7910, and Y+9250 and are approximately 23mm in diameter. At the time of this QAI arrival, ABF welding personnel had completed Y+248, Y+5180, Y+7910 and was just finishing Y+9250, the heated area was a bright yellow at this location. This QAI informed ABF QC personnel Mr. Bernie Docena and Tony Sherwood of this incident and that an incident report will be generated; please see attached photos.
